ZXP Series 8

Summary of Firmware

Release FZ8ME.04.03.00

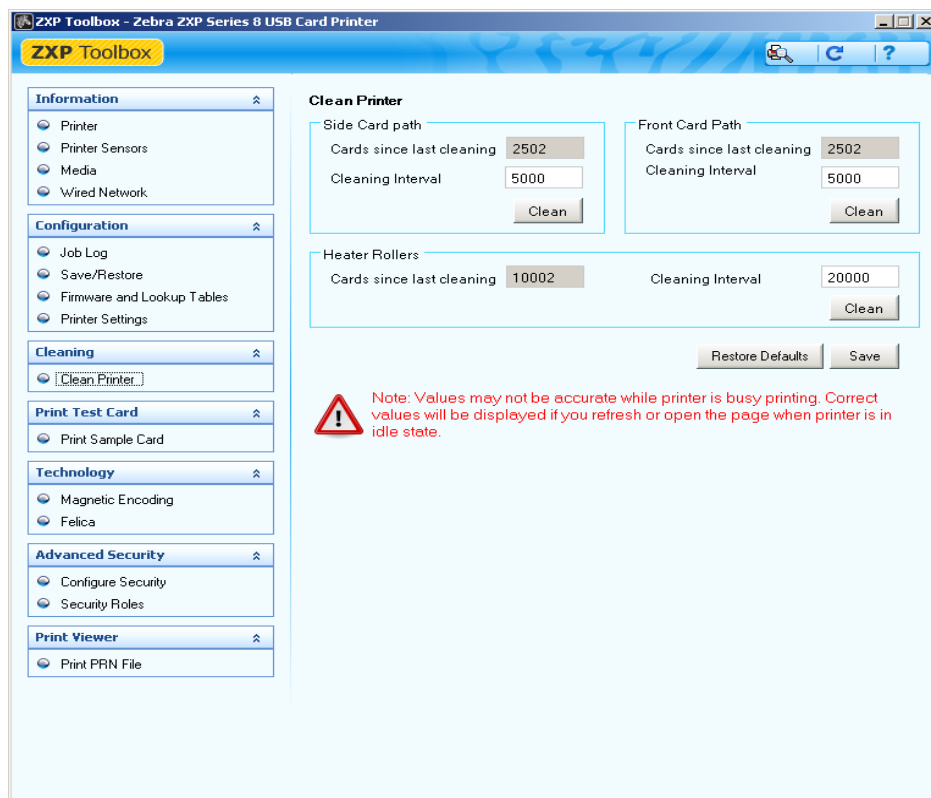
Due to the nature of certain firmware changes made in version 4.03.00, when upgrading the ZXP8 firmware from an older version of firmware, the user may notice a change in some values related to cleaning the printer. As reported in the Toolbox, the values for "Cards since last cleaning" will now be set to one-half of the "Cleaning Interval" value. In the example below, the firmware was upgraded, the counts were reset to one-half of the cleaning intervals (2500, 2500, and 10000, for the Side Card Path, Front Card Path, and Heater Rollers, respectively), and two cards were printed, resulting in the values seen below.
